The Planning Process

Summary

The purpose of this feasibility study is to create a tool to inform short term and long range strategic planning decisions through documentation of educational, financial and community goals. Representing the needs of Seneca Valley School District and the communities the District serves, this tool will offer creative and responsive solutions to those needs. The process analyzed existing facility conditions, building capacity, curricular goals, learning environment best practice, community understanding and expectation, sustainability, and cost to answer the three fundamental questions:

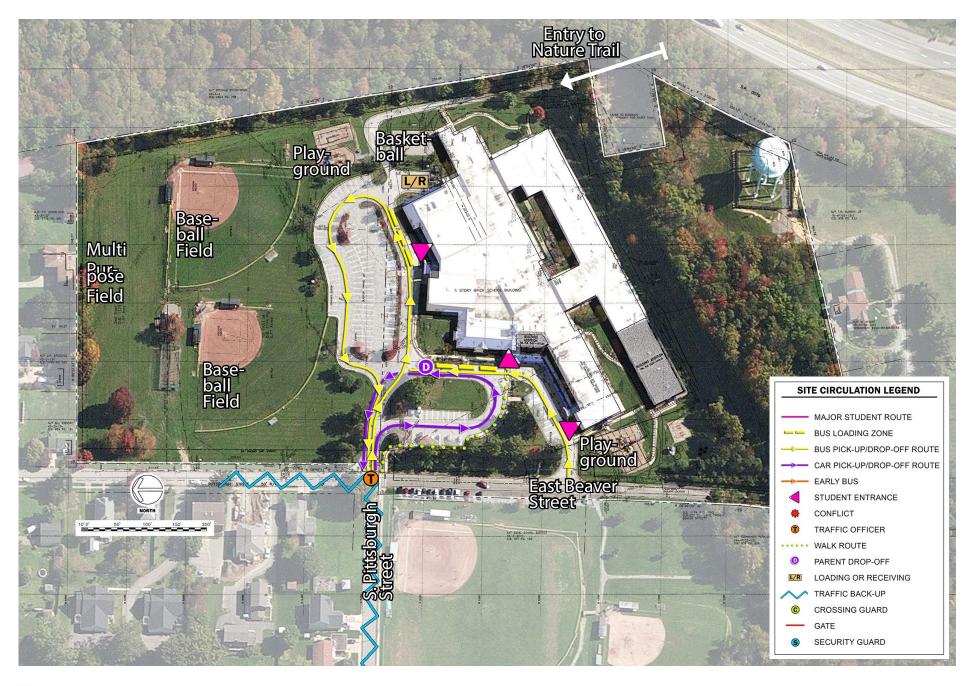
Existing Conditions Connoquenessing Valley Elementary School

KEY SITE CONDITIONS

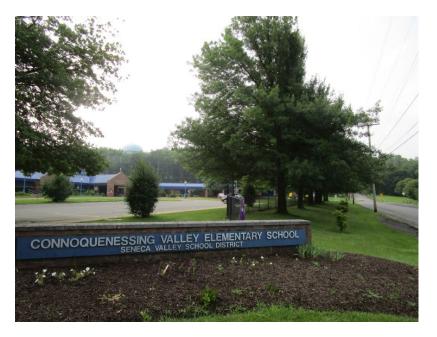
- Signage

- » The school entry sign is well located, but traffic sign disrupts the view. Directional and traffic control signage is adequate, but uncoordinated in style and location.
 - ATHLETICS & PLAY
- Fields
- » There are two fenced baseball fields on campus with batters cages, dugouts, concessions, bleachers and restrooms and one multi-purpose field. The fields are all in excellent condition.
- Playgrounds
 - » Two well-equipped playgrounds allow for a variety of activities.
- Hard surface games
- » A full basketball court adjacent to one playground and the ball fields creates a cluster of recreational activities.
- Trails
 - » A lovely nature trail with interpretive signage begins at the eastern side of the school and winds through the adjacent wooded hillside ending at Pittsburgh Street.

- Recommend preparation of a signage study to coordinate signage message, style, and location.
 - Consider locations for additional event parking, possibly stabilized turf that can remain greenspace when not used for parking.

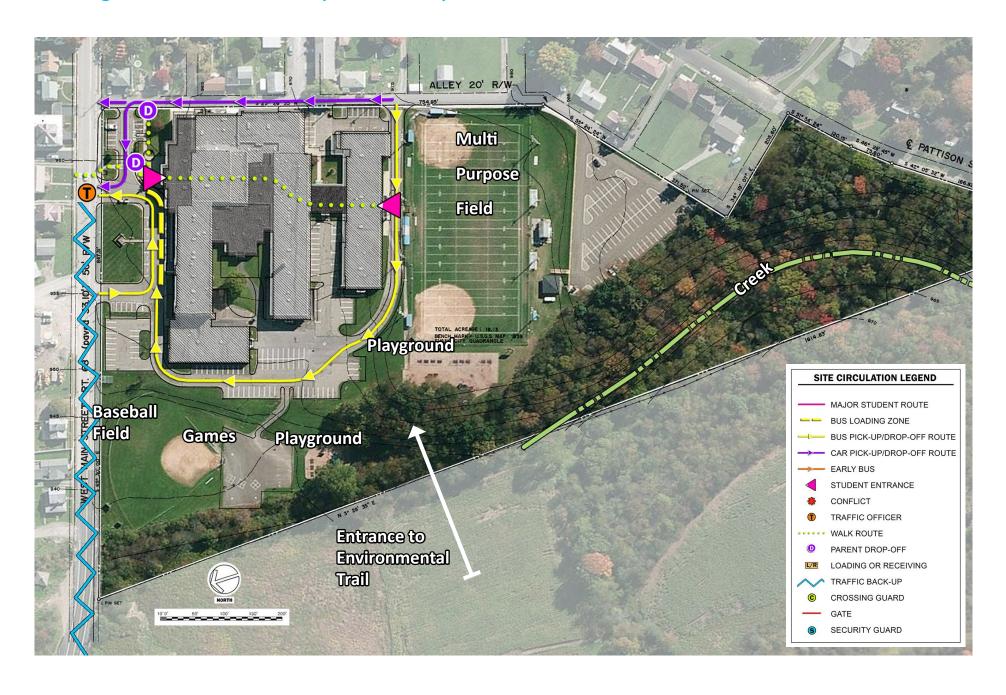
³⁶ Existing Conditions Evans City Elementary/Middle School

KEY SITE CONDITIONS
