# **Seneca Valley**

Feasibility Study Summary All Academic Buildings

**June 13th, 2022**

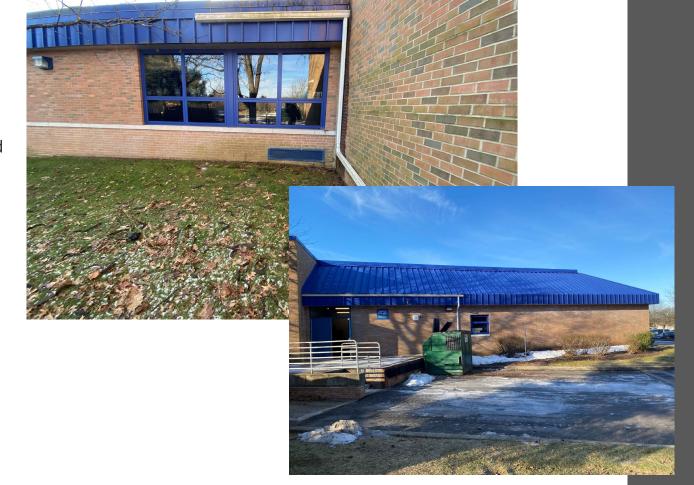
- Exterior Walls
  - Portion of masonry walls have water infiltration
    - Appears to be from lack of thru-wall flashing at roof to high wall locations
    - · Primarily at gable roof elements
    - Damage at loading dock
  - Overall condition of masonry is good, just needs cleaned
  - Unclear if original walls are insulated
- Windows
  - Double paned aluminum windows are in good condition
- Roof
  - Majority of roof is Duro-last membrane and warranty expired in 2020
    - There is noticeable water ponding on areas of the roof
  - Portion of roof (10,000 SF) has been recently replaced an has a warranty until 2041
  - Mansard metal standing seam roof at front of building
    - No Ice guards, limited number of gutters

- Masonry Restoration and thru-wall flashing
- Insulate original (1958) exterior walls
- Replace Roof

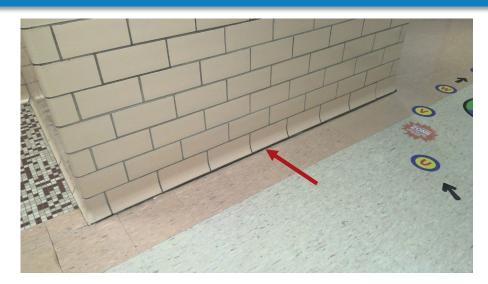
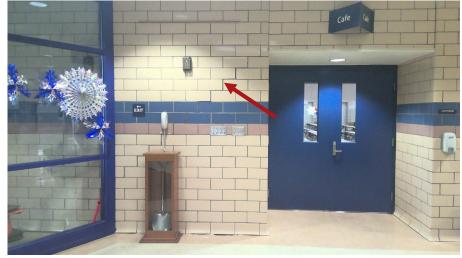
- Flooring
  - Majority of flooring is 12"x12" Vinyl Composite Tile (VCT) and Fritz tile
    - · In fair condition, the tile is cracking and chipping
    - The corridor floor slab in the North-East side of the building is showing signs of settlement
  - Several locations with Carpet tile
    - In good condition
- Interior Walls
  - SGFT and painted CMU
    - In good condition throughout the building
    - Limited step cracking at entry to cafetorium
- Ceilings
  - Acoustical Ceiling Tile (ACT)
    - Most of ceiling is in good condition
    - Ceiling tile are sagging on the North-East side of the building

- Fix floor settlement in North-East side of building
- Replace flooring and ceilings
- New wall finishes and casework
- Reconfigure Nurse Suite

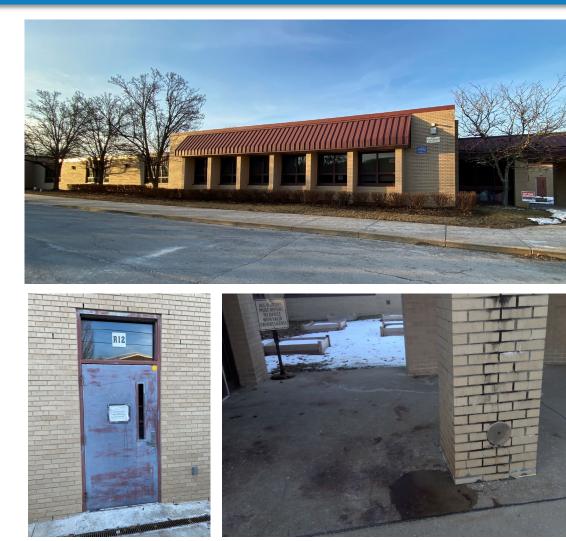
- Exterior Walls
  - Majority of masonry walls are in good condition
    - The main entry canopy is in poor condition
    - Masonry cleaning and caulking should be considered.
    - Original walls do not appear to be insulated
- Windows
  - Double paned aluminum windows were installed in 1990
    - Replacement should be considered as part of large renovation
- Roof
  - Recently replaced with warranty through 2041
  - Mansard metal roof has faded, but appears to be in good condition

- Masonry Restoration and thru-wall flashing
- Insulate original (1958) exterior walls
- Replace windows
- Replace Mansard Roof

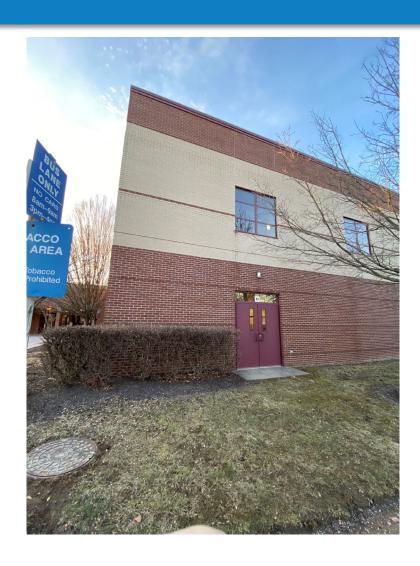
- 1968 walls are in fair condition, areas need to be cleaned and repointed
- It is unclear if original walls are insulated
- 1996 addition walls are generally in good condition, cleaning is necessary in some locations

- Double paned aluminum windows
  - 1968 windows are rusting and should be replaced as part of renovation project
  - 1996 addition windows are in good condition

- Recently replaced with warranty through 2032 and 2035
- Built up roof is scheduled for replacement in 2022

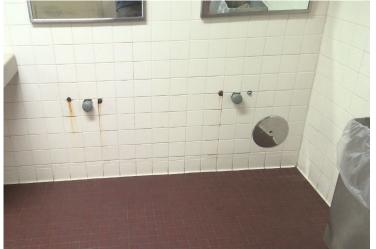
- ES has fritz tile, terrazzo, and 9x9 tile
  - Poor condition
  - 9x9 tile should be remediated
- MS has 12"x12" VCT
  - · generally, in good condition, some areas are damaged
- · Ceramic/Quarry Tile
  - · Located in restrooms, good condition

- · ES walls are brick and plaster
  - · Fair condition, very dark and dated
- MS walls are glazed CMU and painted CMU
  - Good condition, very dated

- · ES has wood and wood beam ceilings with some ACT
  - Very dark and poor acoustics
- MS had 2x4 ACT ceiling
  - Fair condition

• ES door hardware is not ADA compliant and should be replaced

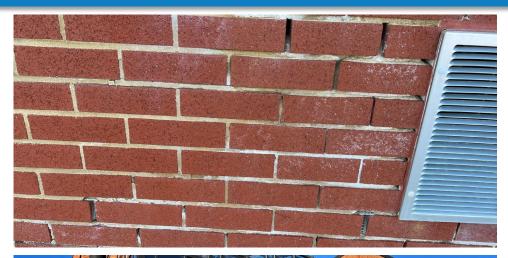
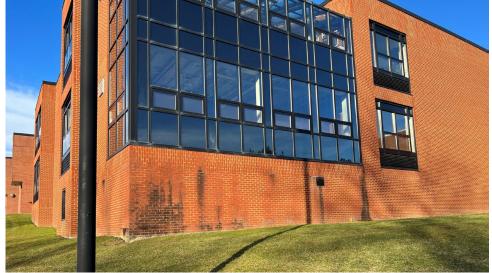
- Exterior Walls
  - Majority of brick facade walls is in good condition
    - Needs cleaned
    - 1972 portion of building brick needs repointed and appears to be uninsulated
    - No thru-wall flashing and weeps/vents present in portions of building
    - Significant water infiltration at greenhouse
- Windows
  - Double paned aluminum windows are in fair condition
- Roof
  - 44,000 SF of Duro-Last roof is warranted through 2032-2035.
  - 45,000 SF of roof is scheduled for replacement in 2022
  - The remainder of the roof does not have warranty information available and is not Duro-Last
- Exterior doors are in great condition

- Exterior
  - Masonry Restoration and thru-wall flashing
  - Insulate original (1972) exterior walls
- Interior
  - Replace Quarry Tile flooring and install new flooring
  - Replace ceilings as necessary
  - New wall finishes and casework
- MEP
  - New chiller and pumps
  - LED lighting fixtures

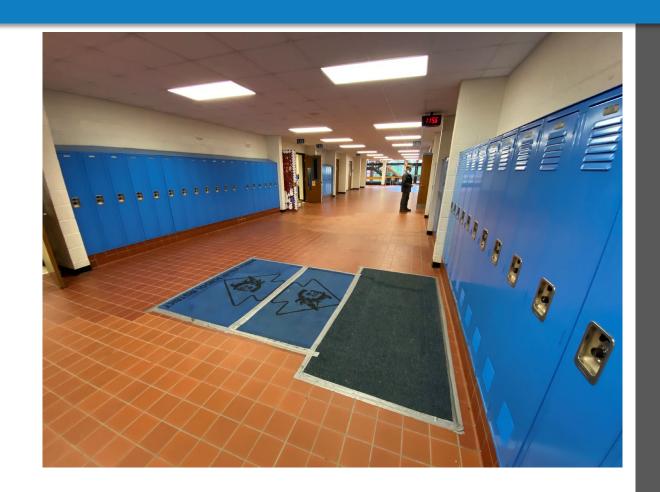
- Flooring
  - Quarry Tile Corridors and Cafeteria
    - Needs replaced portion being replaced in 2022
  - Carpet tile Main Office and Music Suite
    - Fair condition
  - VCT Classrooms
    - Good condition
- Interior Walls
  - Painted CMU
    - · In good condition throughout the building
  - Ceramic Tile Restrooms
    - In good condition
- Ceilings
  - 2'x2' suspended ACT ceiling throughout building
    - good condition

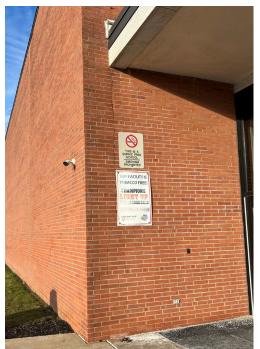
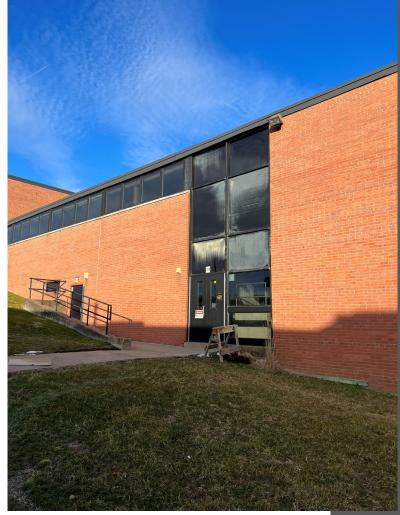
- Brick is in fair condition
  - Needs cleaned, repointed, and caulking
  - Noticeable step cracking at several locations
  - · Original walls are not insulated
- Plaster soffits are failing and should be replaced
- Exterior canopy is in poor condition

Aluminum curtainwall is in poor condition and has extensive water infiltration

- Nearly all roof warranty expires in 2024
- 2003 addition is now recommended for replacement per Duro-Last report

- · Masonry Restoration and thru-wall flashing
- Insulate original (1964) exterior walls
- Replace Roof
- Replace window systems

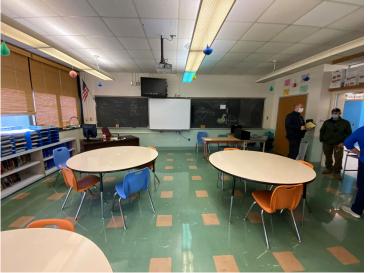
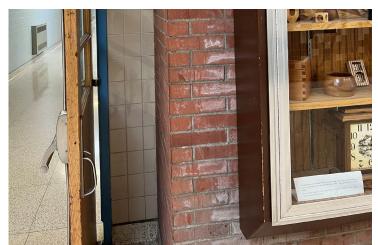
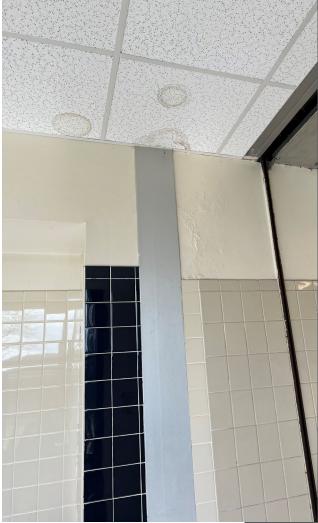
- Flooring
  - Carpet tile Main Office and Music Suite
    - Good condition
  - VCT/9"x9" tile Classrooms
    - VCT located in newer area; good condition
    - 9"x9" tile should be remediated
  - Terrazzo Corridors
    - · Fair condition; some cracking was noticed
- Interior Walls
  - Painted CMU
    - In good condition
  - Ceramic Tile & Gyp Bd
    - In good condition; some tile is missing and damaged Gyp Bd
- Ceilings
  - 2'x2' suspended ACT ceiling throughout building
    - Mostly good condition; some staining was observed

- · Remediate flooring and install new flooring
- Replace ceilings as necessary
- · New wall finishes and casework
- Reconfigure District Office to performing arts suite
- Rebuild stair towers to be code compliant

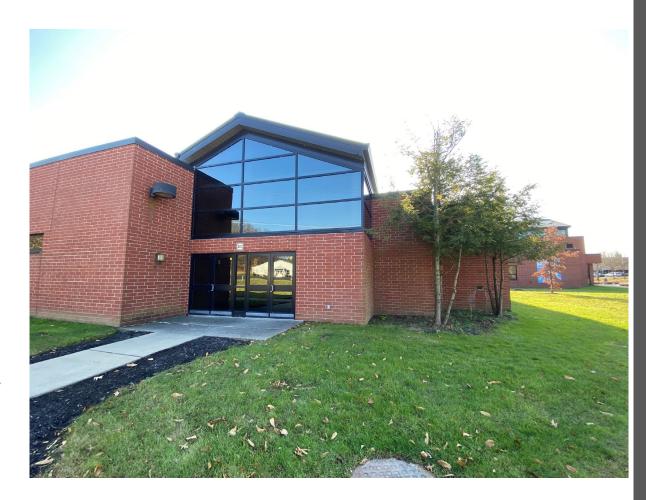
- Exterior Walls
  - Brick is in good condition
    - Areas close to ground level need cleaned
- Windows
  - Double paned aluminum windows are in good condition
  - Skylight is showing signs of water infiltration
- Roof
  - Nearly all roof warranty expires in 2028
  - 10,000 SF is recommended for replacement per Duro-Last report

- Exterior
  - Masonry cleaning
  - Repair/replace skylight
- Interior
  - Replace Fritz Tile flooring and install new flooring
  - Replace ceilings as necessary
  - New wall finishes
- MEP
  - New chiller and pumps
  - LED lighting fixtures

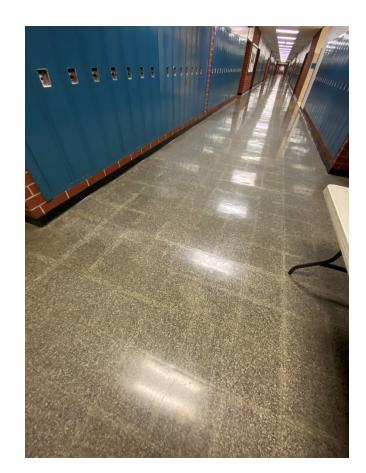
- Flooring
  - Carpet tile Main Office and Music Suite
    - Good condition
  - VCT- Classrooms & 2007 Corridors
    - Good condition
  - Terrazzo Corridors
    - Good condition; some cracking was noticed
  - Fritz Tile Corridors
    - Poor condition
- Interior Walls
  - Painted CMU
    - In good condition
  - Ceramic Tile & Gyp Bd
    - In good condition; some tile is missing and damaged Gyp Bd
- Ceilings
  - 2'x2' and 2'x4' suspended ACT ceiling throughout building
    - Mostly fair to good condition
