The Planning Process

Summary

The purpose of this feasibility study is to create a tool to inform short term and long range strategic planning decisions through documentation of educational, financial and community goals. Representing the needs of Seneca Valley School District and the communities the District serves, this tool will offer creative and responsive solutions to those needs. The process analyzed existing facility conditions, building capacity, curricular goals, learning environment best practice, community understanding and expectation, sustainability, and cost to answer the three fundamental questions:

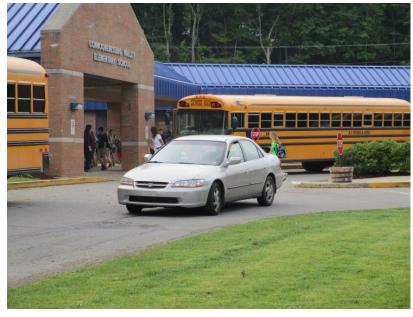
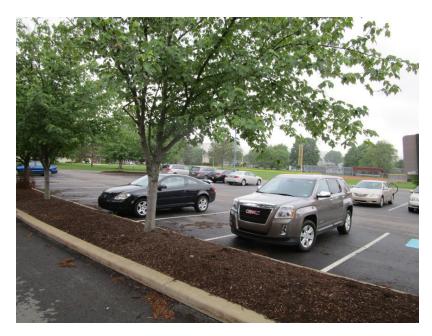
- » The school entry sign is well located, but traffic sign disrupts the view. Directional and traffic control signage is adequate, but uncoordinated in style and location.
 - ATHLETICS & PLAY
- Fields
- » There are two fenced baseball fields on campus with batters cages, dugouts, concessions, bleachers and restrooms and one multi-purpose field. The fields are all in excellent condition.
- Playgrounds
 - » Two well-equipped playgrounds allow for a variety of activities.
- Hard surface games
- » A full basketball court adjacent to one playground and the ball fields creates a cluster of recreational activities.
- Trails
 - » A lovely nature trail with interpretive signage begins at the eastern side of the school and winds through the adjacent wooded hillside ending at Pittsburgh Street.

- Recommend preparation of a signage study to coordinate signage message, style, and location.
 - Consider locations for additional event parking, possibly stabilized turf that can remain greenspace when not used for parking.

- » F1 Consider a redesign of the school entrance to increase curb appeal including signage, landscaping and art installations.
 - » F2 Consider location of a demonstration rain garden between building wings.

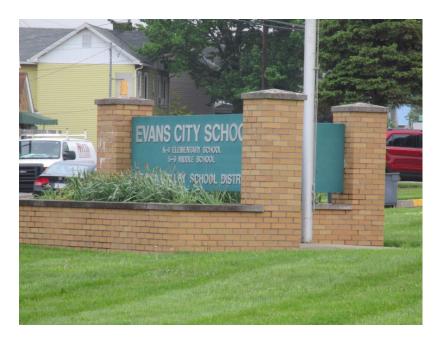
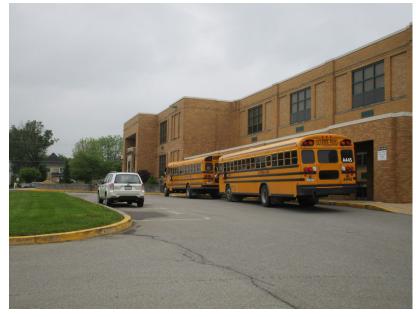
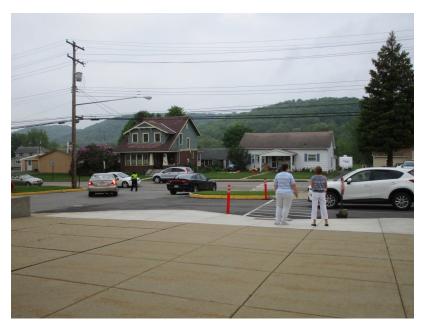
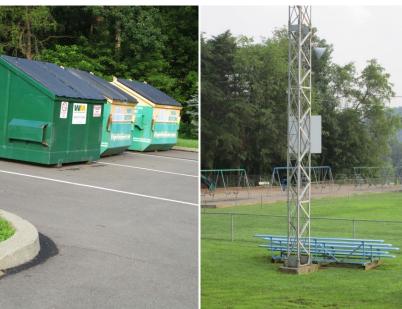
» Dedicated sidewalk circulation within the school property is limited. There are public sidewalks on Main Street that connect to the school circulation system. Walkers must access the school via a well-marked crosswalk through the car drop-off route.

Although a thorough ADA review was not conducted, it appears that the paved access route to the lower play ground is not ADA accessible.

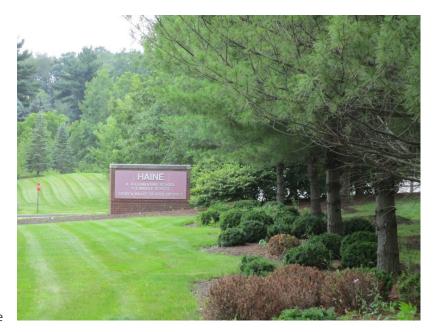
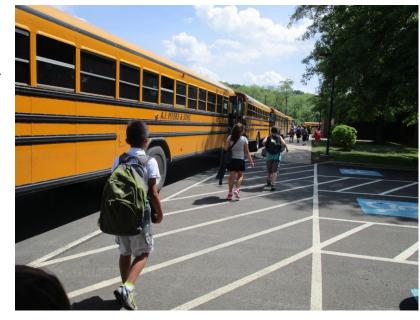
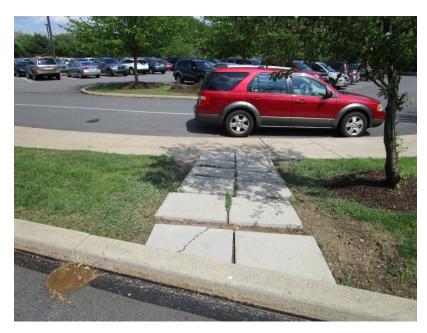
- Sidewalks
- » The main pedestrian access to the middle and elementary school entrances is provided by a wide crosswalk connecting the bulk of the parking to the school with the front sidewalk and entry plazas. A second 'informal' pedestrian access to the school is to the south. While there is no marked cross-walk, a path of walking stones is provided to the parking lot. There is an extensive

system of sidewalks that surround the school connecting various entrances, activities and the public side walk system. While a comprehensive ADA analysis was not performed, it was observed that tactile warning strips are missing on some ramps.

- » C5 Consider redesign of rear parking lot area to segregate play from parking and possibly increase parking.
 - Recommend undertaking an ADA audit and preparing a plan to address any non-compliant items.

- Consider widening sidewalks where needed to accommodate the volume of foot traffic.
 - Recommend preparation of a signage study to coordinate signage message, style, and location.

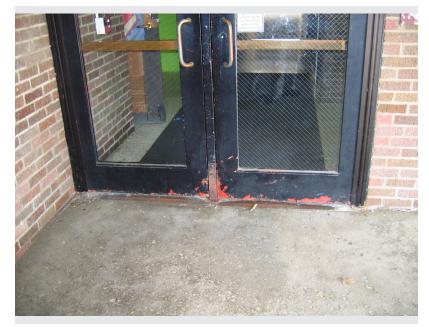
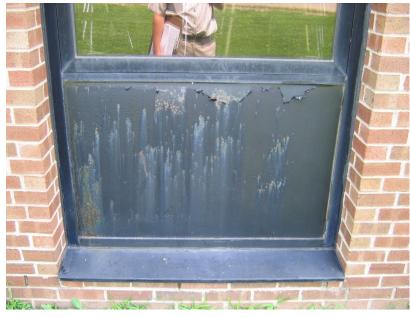
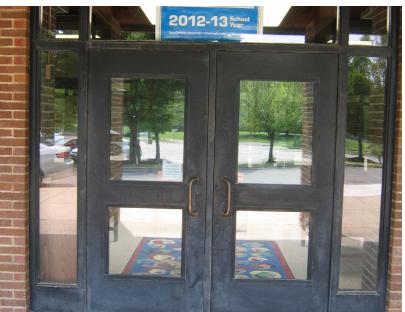
- EXTERIOR RATING: POOR / GOOD
 - The building was initially constructed in 1968 and was subsequently added onto and/or renovated in 1985, 1990 and 1996.
 The façade is comprised of brick. The 1996 addition existing masonry walls are in good condition, however the original 1968 masonry walls are in fair condition

some areas need to be repointed.
 Masonry should be cleaned as part of a larger renovation. Brick areas near grade and concrete should be repointed.
 - Exterior lintels in the 1968 portion, including the interior courtyard do not appear to be galvanized and are rusting. These lintels should be anticipated for replacement in the near future. Lintels and soffits in the 1968 portion are in poor condition and should be replaced.
 - Exterior caulking is in fair to poor condition and should be replaced at all masonry.

- Exterior doors and frames in the 1968 portion are painted hollow metal in poor condition and should be replaced. Exterior doors and frames in the 1996 portion are aluminum and are generally in good condition. Middle School main entry doors are in fair condition and should be considered for replacement in the near future.
- Exterior windows are aluminum, double-paned with operable bottom sashes. Windows in the 1968 portion are rusting, in poor condition and should be replaced. Windows in the 1996 portion are aluminum in good condition.
- It is unclear if the original 1968 building envelope was insulated as part of subsequent renovations, but it appears not to have been. If not, this portion of the building should be insulated as part of any extensive renovations.
- The 1996 addition exterior canopy brick and lintels are visibly in good condition.
- 2. ROOF
 RATING: FAIR

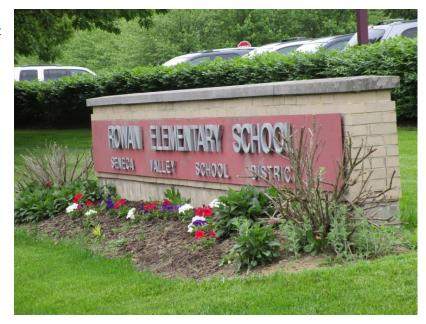
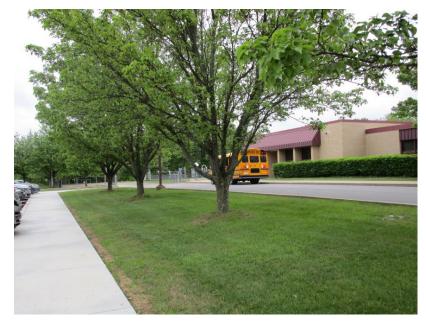
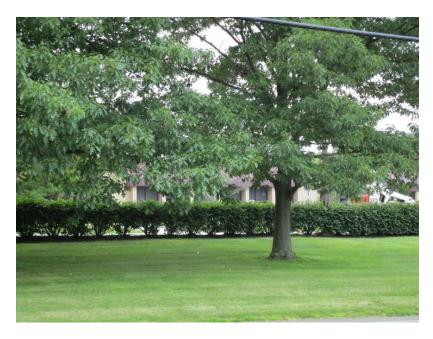
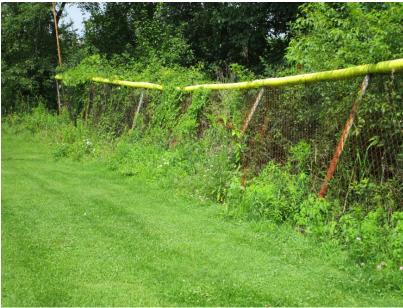
- » There is more than adequate parking. Two western lots not used during a typical day, one lot is gated and used for play.
- Sidewalks
 - » There are a few walkers at Rowan, they enter in the eastern front door.
- Loading and service
- There is no loading dock at Rowan, only a receiving area; staff reports a dock is needed. In addition to receiving, the service area also has the dumpsters making this area very tight for truck maneuvering. The service road is in good condition but the adjacent wall is leaning and the fence rusting.
- Pavement and curbs condition
- » The front concrete plaza and sidewalk is in good to excellent condition with some minor heaving and joint popping. The front parking lot and drop-off area pavement is in excellent condition. Other lots are in fair to good condition. Note that curbs and sidewalks were actively being repaired during the pavement assessment.

» The school entry sign is in good condition but difficult to see because it is parallel to the road and somewhat set back. Directional and traffic control signage is adequate, but uncoordinated in style and location.

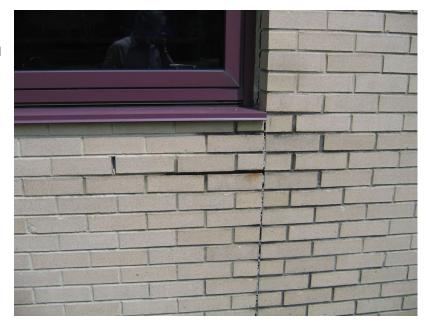
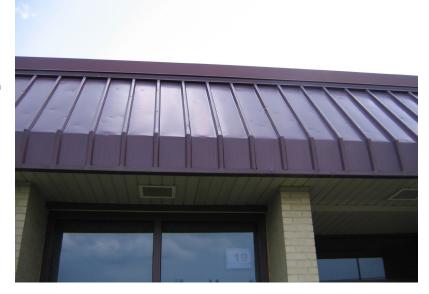
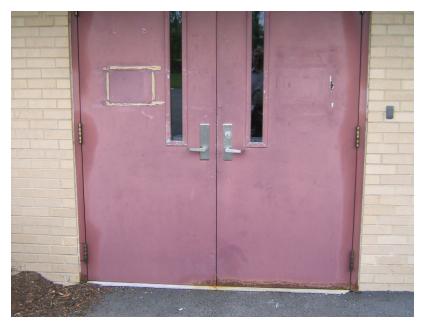
- Exterior masonry should be cleaned as part of a larger renovation.
- The rear building metal awning has been damaged by balls from the adjacent baseball field. Although unsightly due to damage, the metal roof appears to still be water tight.

- RATING: FAIR
 - The roof system is a Duro-Last singleply roof installed in 2005. The roof has a 15 year warranty. It should be anticipated for replacement after

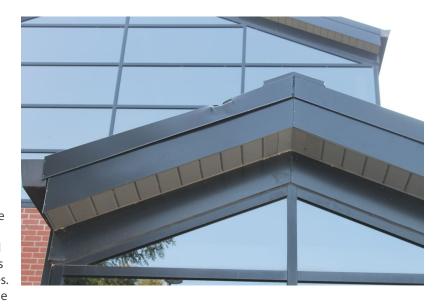
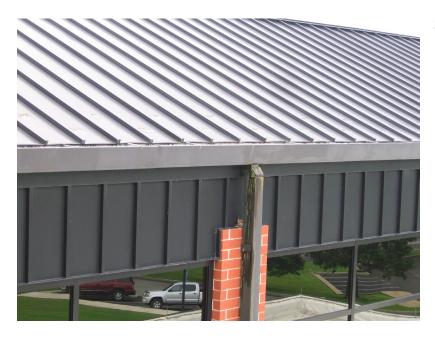
RATING: GOOD

• The roof system is a combination TPO roof installed in 2007 (classroom addition), a single ply Duro-Last roof installed in 2013, and limited standing seam metal roofing, installed in 1994. The TPO roof has a 10 year warranty. The Duro-Last roof has a 15 year warranty. The TPO roof is nearing its warranty and should be monitored for replacement as the warranty expiration date approaches. The Duro-Last roof should be serviceable for the foreseeable future. The standing seam metal roof appears to be in good condition with no reported leaks. A Kalwall roof is located at the 2007 addition. No leaks have been reported at this roof. Destructive testing on the roof membrane and insulation was not performed at the time of the visit. However, this type of testing would provide a more detailed understanding of insulation type, thickness, and the condition of the existing substrate. Copings and flashings are painted aluminum in fair to good condition depending on location. Some dents in copings were observed at the rear and side of the building. Gutters and downspouts at main entry metal roof show signs of leaking which should be addressed.

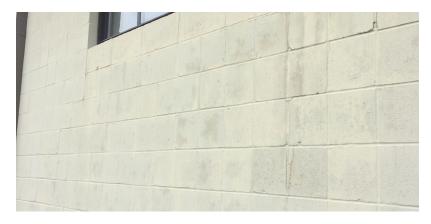
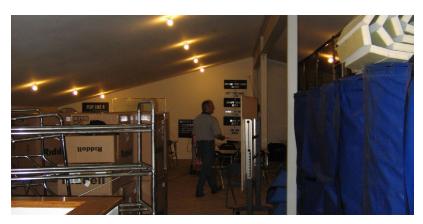
- Interior finishes consist of a finished gypsum board ceiling, wood grain T-111 siding interior partitions and carpet flooring. All interior finishes are in poor condition.
- 4. CODE COMPLIANCE/ACCESSIBILITY

BUILDING SAFETY AND SECURITY RATING: POOR

No exterior or interior surveillance cameras were observable. The building is locked by a lockable handle set.

The building exterior and interior are in poor condition. The building should be reconstructed with a more substantial structural and architectural system. Security cameras should be provided, if not currently provided off of the existing IHS.
