# **Seneca Valley**

Feasibility Study Summary All Academic Buildings

**June 13th, 2022**

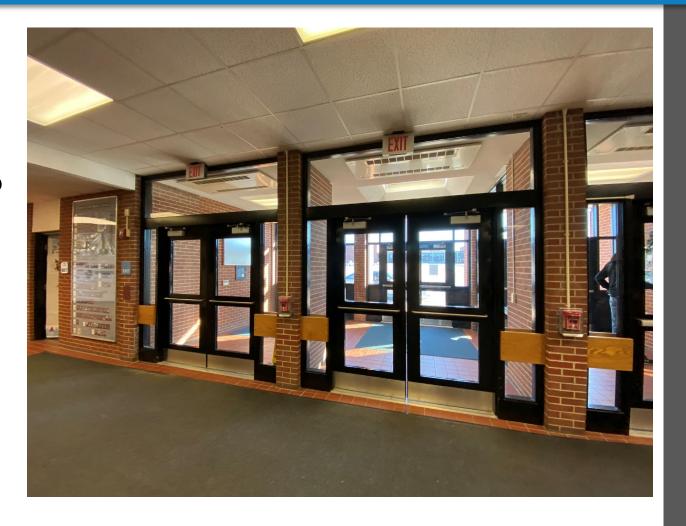
- Exterior Walls
  - Majority of brick facade walls is in good condition
    - Needs cleaned
    - 1972 portion of building brick needs repointed and appears to be uninsulated
    - No thru-wall flashing and weeps/vents present in portions of building
    - Significant water infiltration at greenhouse
- Windows
  - Double paned aluminum windows are in fair condition
- Roof
  - 44,000 SF of Duro-Last roof is warranted through 2032-2035.
  - 45,000 SF of roof is scheduled for replacement in 2022
  - The remainder of the roof does not have warranty information available and is not Duro-Last
- Exterior doors are in great condition

- Exterior
  - Masonry Restoration and thru-wall flashing
  - Insulate original (1972) exterior walls
- Interior
  - Replace Quarry Tile flooring and install new flooring
  - Replace ceilings as necessary
  - New wall finishes and casework
- MEP
  - New chiller and pumps
  - LED lighting fixtures
